OZARK LEAD TAILINGS DAM
REYNOLDS COUNTY, MISSOURI
MO 30160

PHASE 1 INSPECTION REPORT NATIONAL DAM SAFETY INSPECTION

APRIL 1981

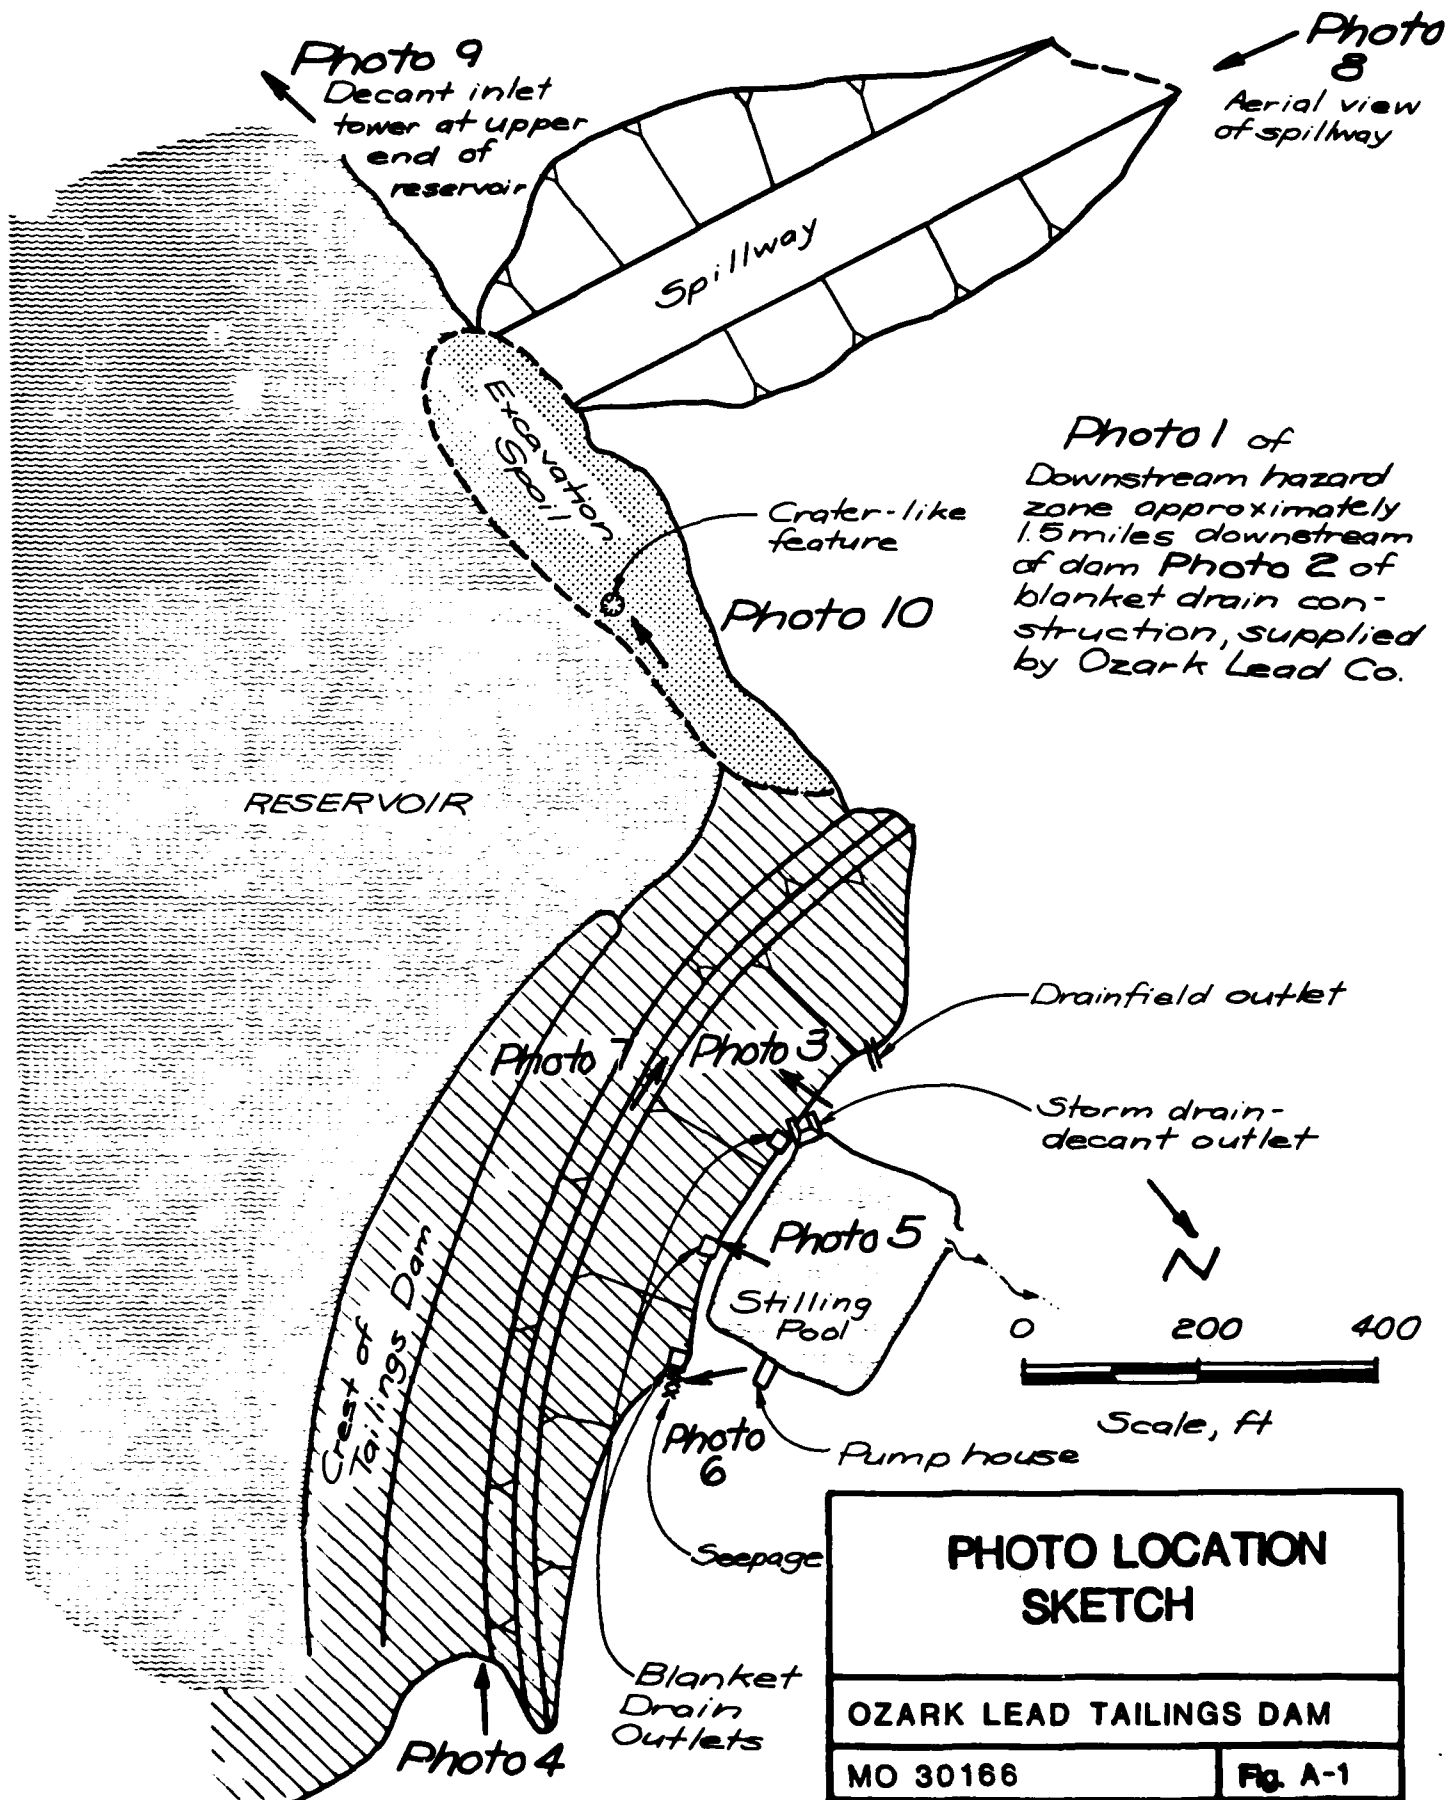
- d. **Hazard classification.** The St Louis District (SLD), Corps of Engineers, has classified this dam as having a high hazard potential; we concur with this classification. The SLD estimated damage zone length extends approximately 10 mi downstream. Within this estimated damage zone are numerous occupied dwellings, a church, and several Missouri State Highways. The contents of the downstream damage zone were verified by aerial reconnaissance (Photo 1). The potential for loss of life and property is high in the event of sudden failure of the dam.

1. Typical contents of downstream hazard zone. Dam is approximately 1.5 miles upstream, out of picture to the upper right.
